Historic Structure Report

**THE ADMINISTRATION BUILDING
(THE RYAN CENTER)**

**Gateway National Recreation Area
Floyd Bennett Field Unit**

By
Judith A. Quinn

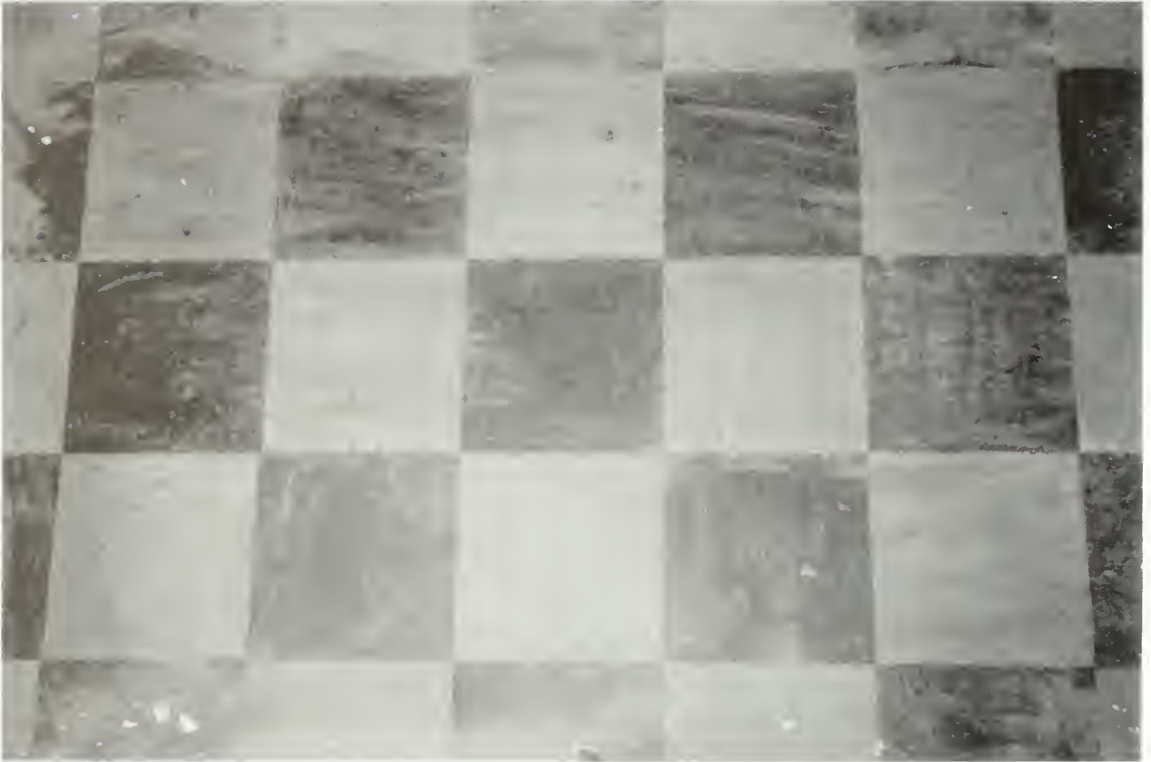
- Linoleum floor with inlaid pattern of checkerboard, diamonds, and rectangles with solid borders (colors include green, red, and blue).
Extant in passenger tunnel but extremely deteriorated and water-damaged.
- Checkerboard-pattern linoleum flooring with solid perimeter border of 9-inch squares (generally buff and dark brown).
Extant but deteriorated in Rooms 107, 108, 109, 202 - 210, and 214 - 222.
- Marbleized linoleum, dark green and white, 12-inch squares.
Extant but very deteriorated in second-floor lobby; removed from first-floor lobby in 1980s to make way for "wood" vinyl tiles.
- Floors of white, 1-inch square ceramic tiles.
Extant and in good condition in original bathrooms in Rooms 205-209, 213, and 215-220.

Figure 188. Original linoleum flooring, Room 107.

- Restore passenger-tunnel flooring; replicate original linoleum colors and pattern and install.
- Replace all first- and second-level linoleum floors with new linoleum flooring in colors and patterns matching the original.
- Maintain ceramic-tile floors in all bathrooms that are included in the rehabilitation plan.

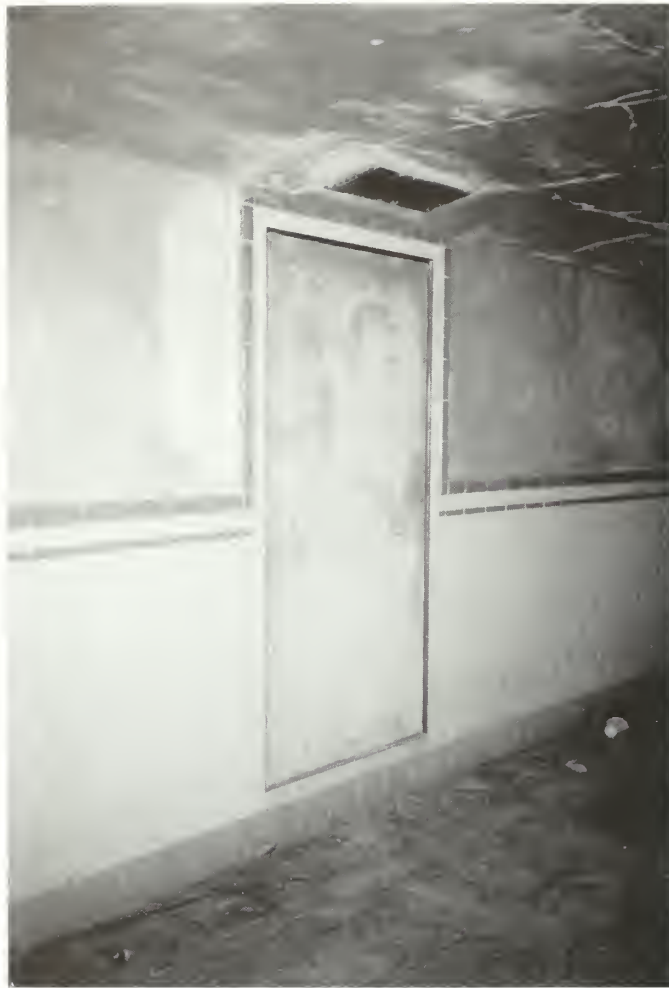
- Glazed ceramic-tile baseboard, wainscot, and wainscot cap: multicolored (buff, yellow, blue).
Extant and in good condition in the passenger tunnel.
- Rectangular display panels, framed with blue ceramic tiles, spaced along walls of passenger tunnels.
Extant and in good condition in the passenger tunnel.
- Black marble baseboard.
Extant and in good condition in hallways (Rooms 101N, 101S, 201N, and 201S) and in lobby/atrium areas (Rooms 101 and 201), including along the walls of Stairways # 2 and 5.
- Buff marble wainscot and wainscot cap.
Extant and in good condition in first-floor hallways (Rooms 101N and 101S) and first-floor lobby (Room 101), including along the walls of Stairways # 2 and 5.

Figure 191. Glazed ceramic-tile baseboard, wainscot, and display panel in passenger-loading tunnel.

- Clean and preserve ceramic-tile baseboard, wainscot, and wainscot cap of the passenger tunnel.
- Maintain exhibit wall panels in the passenger tunnel.
- Preserve all marble baseboards.
- Preserve all marble wainscot and wainscot caps.
- Clean all imitation Caen stone, remove layers of paint, and restore to original finish as determined by a detailed finish analysis.
- Preserve original plaster walls where possible, and replace in kind where deterioration is too severe for restoration.
- Preserve plate-glass window wall of Room 117.
- Preserve ceramic-tile walls and decorative tile borders in situ where possible. Remove and save samples of materials for documentation if bathrooms are eliminated.

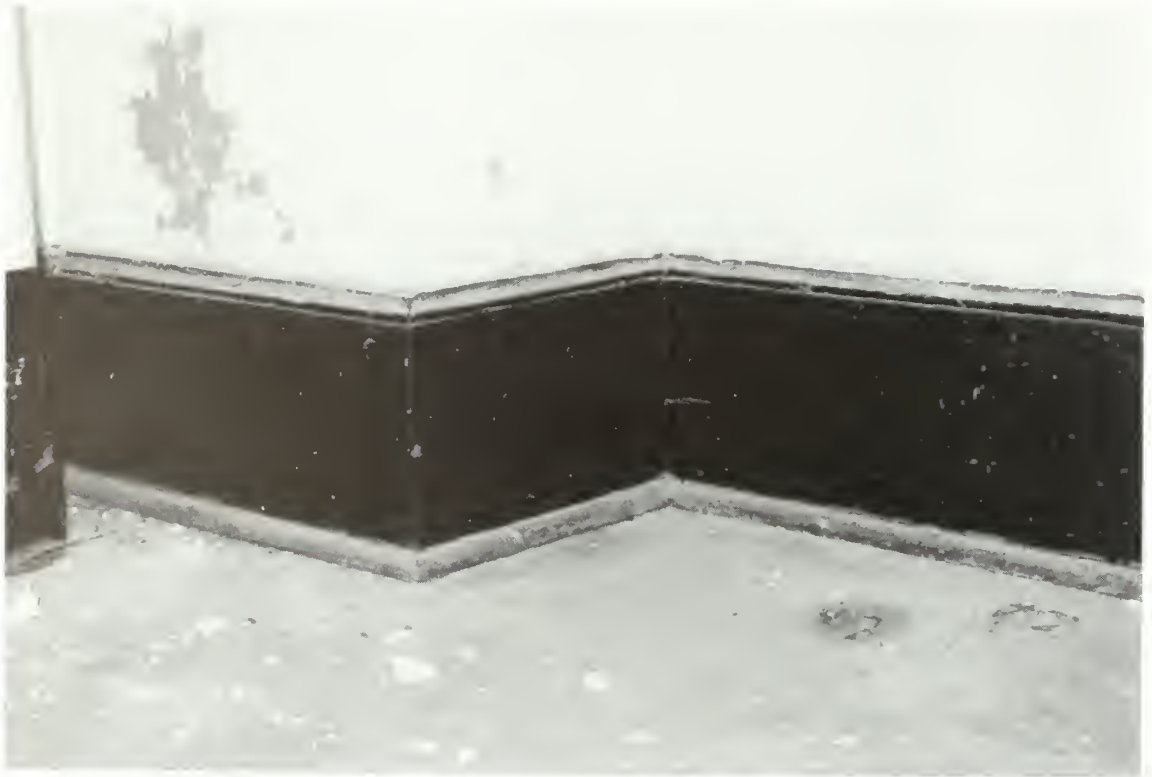
- Three-piece wooden baseboard.
Extant on at least one wall and in varying condition in Rooms 004 and 005; Rooms 103, 104, 107, 108, 110, and 114; and Rooms 202-210, 212, 214-218, 220, and 221.
- Molded wooden chair rail.
Extant on at least one wall and in good condition in hallways 201N and 201S, and Rooms 110, 117, 202, 203, 205, 206, 214, 215, 216, and 220.
- Wall panel moldings.
Extant on at least one wall and in varying condition in Rooms 205, 206, 214, 215, 216, 219, and 220.
- Molded wooden doorway trim and all doorway frames facing the lobby/atrium on the first and second floors. (See Appendix C for molding profile.)
- Plain wooden doorway frames with simple curved edge in second-floor entry, bathroom, and closet doorways, except those facing atrium. (See Appendix C for profile.)

Figure 194. Original three-piece baseboard, Room 108, northwest corner.

- Preserve original baseboard where possible; replicate materials, dimensions, and profile of original baseboard where replacement baseboard is needed.
- Preserve or replace in kind original chair rails in rooms where extant, particularly in Rooms 110 and 117, and in the second-floor hallways.
- Preserve panel moldings where extant in second-floor rooms as an example of original appearance of room.
- Preserve all original wooden doorway frames and trim.

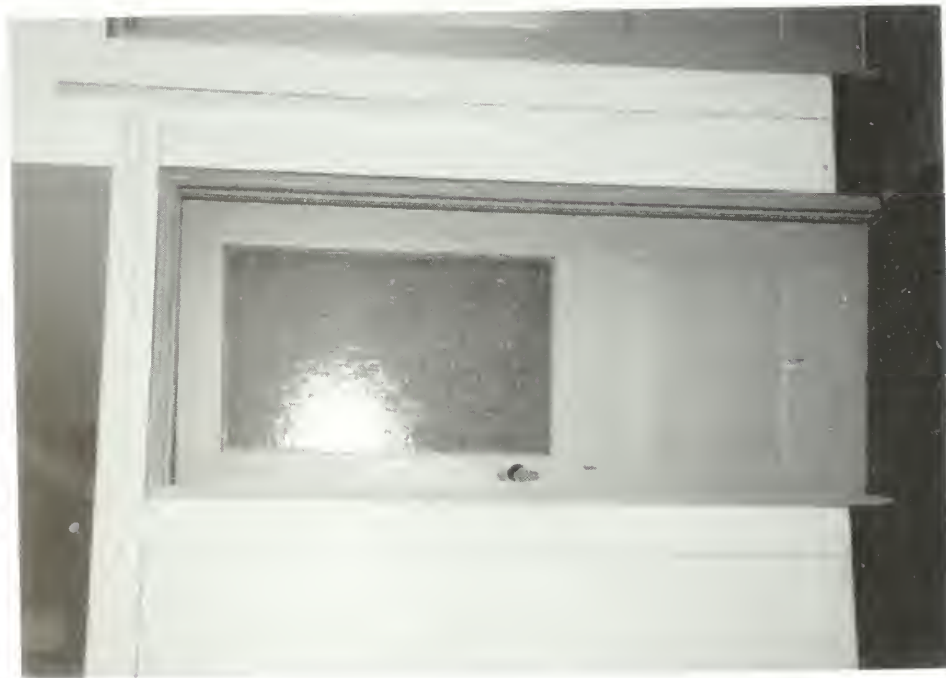
- Original wooden doors with “chipped glass” light in upper panel.
Examples extant at D 1-3, D 1-23, D 1-26, D 1-29, D 1-30, D 1-46, D 2-1, D 2-2, D 2-23, D 2-27, D 2-52.
- Original double French doors, wood with 10 lights per leaf.
Extant and in good condition at D 1-22 and D 1-36.

Figure 196. Original wood door with "chipped" glass in upper panel (D 1-30).

- Preserve and reuse original doors at all possible locations on first and second floors.
- Replace missing and damaged interior doors with doors that match the originals in material and design.
- Maintain glass transoms above doorways leading into rooms from the lobby and hallways.

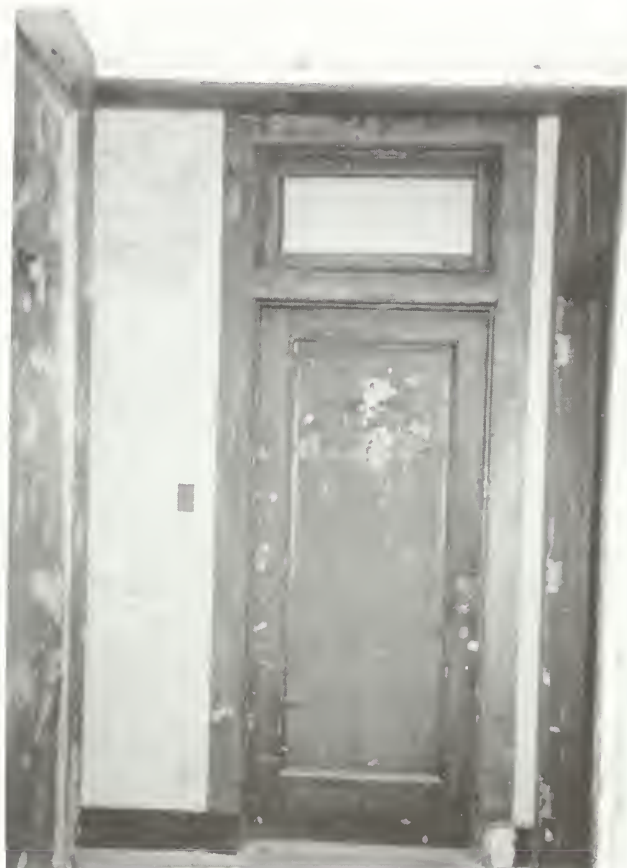
- Original wood-veneer single-panel doors.
Extant in most second-floor hall doorways, closets, and bathrooms.
- Metal-clad fire doors, painted and grained. (Metal doors open to Rooms 108, 112, 207, 208, 216, and 217.)
Extant but in rusted condition in D 1-16, D 1-25, D 2-11, D 2-16, D 2-36, and D 2-41.
- Transoms: rectangular, with obscure glass in wood frames; above most hallway doorways on first and second floors.

Figure 199. Metal-clad fire doors, painted and grained, Room 208 (D 2-16).
